# Town of Arlington

### Final Application for FY20 CPA funding

The goals of this project are to begin to implement the recommendations of the Preservation Master Plan for the Old Burying Ground ("OBG") completed by Ray Dunetz Landscape Architecture, Inc. (RDLA) that was generously funded by a previous CPA grant in 2018 and is appended to this application. Thank you again for the prior planning grant; it is our hope you will find the Preservation Master Plan lays the groundwork for a thoughtful restoration effort over the years to come.

# OLD BURYING GROUND & TOMBS AT MOUNT PLEASANT CEMETERY PRESERVATION PLAN

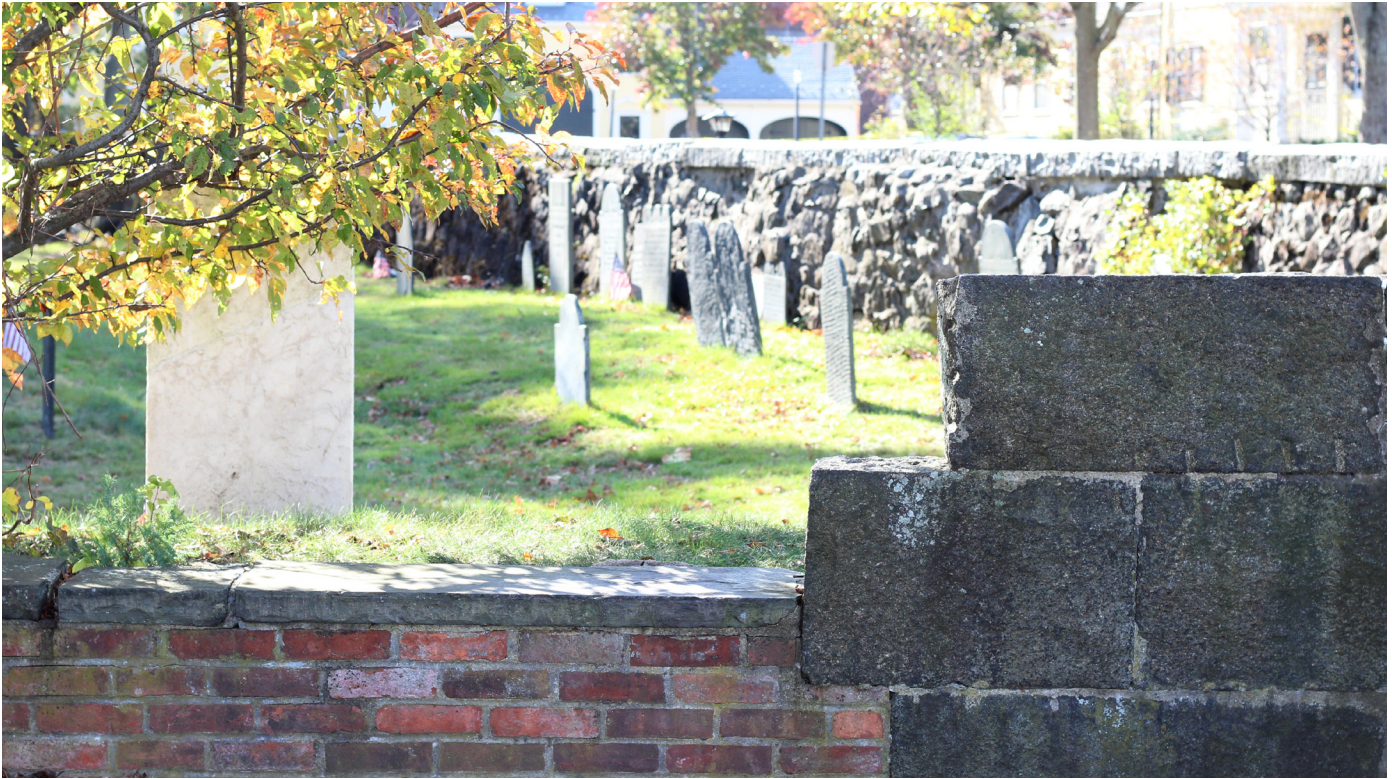
OBC Walls Vary in Their Construction and Condition; View of Brick, Granite Block and Fieldstone Walls Beyond

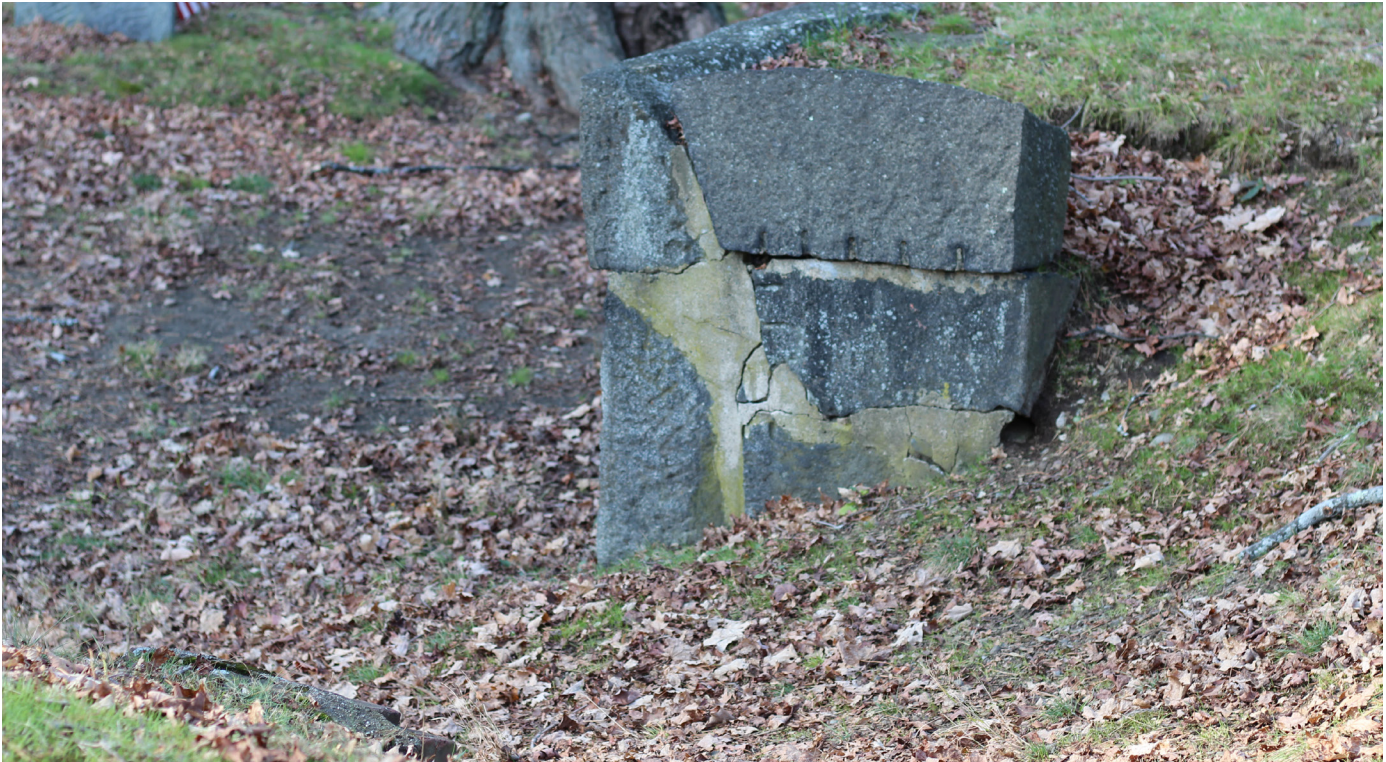
Masonry Side Walls of OBG Northeast Tombs Have Shifted

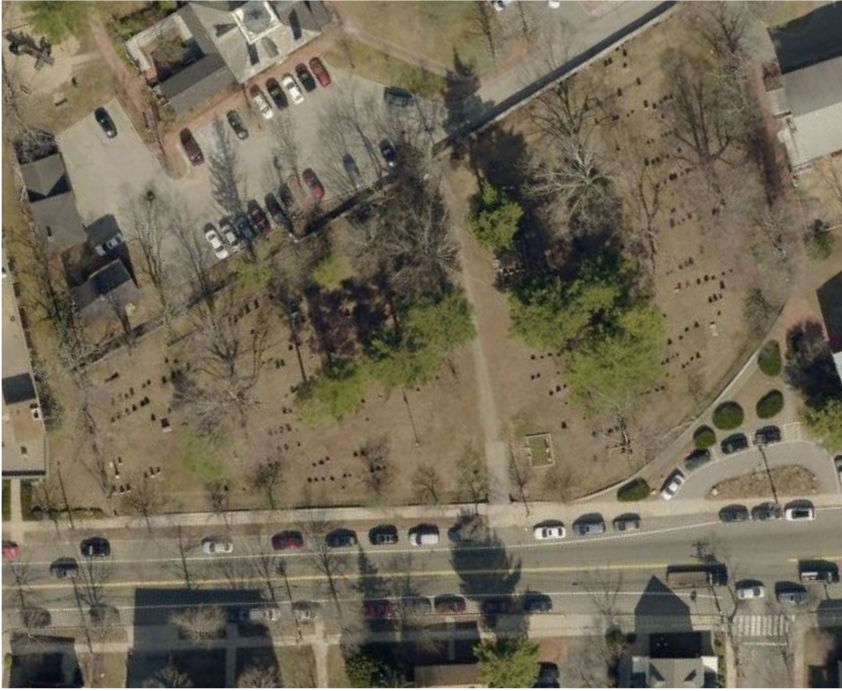
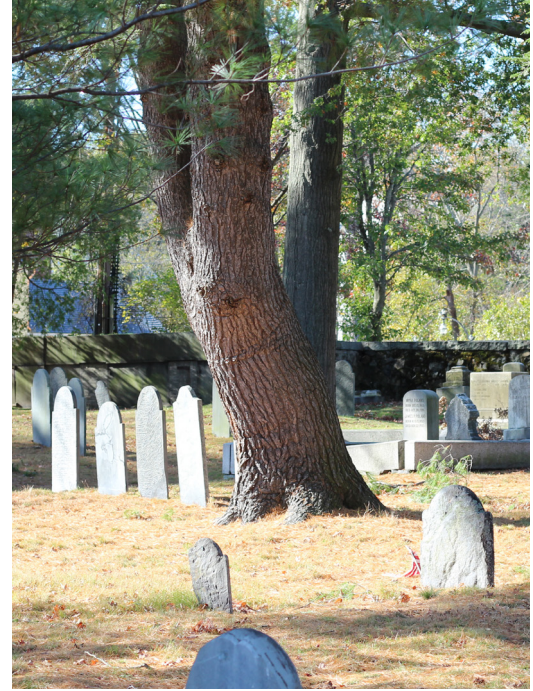
The soils at OBG are infertile, poorly drained and compacted. These conditions have affected the quality of lawns and the health of trees. A detailed soils report prepared by Pine and Swallow, soil scientists, is included in the Appendix. ➤

OBG Lawn in Poor Condition

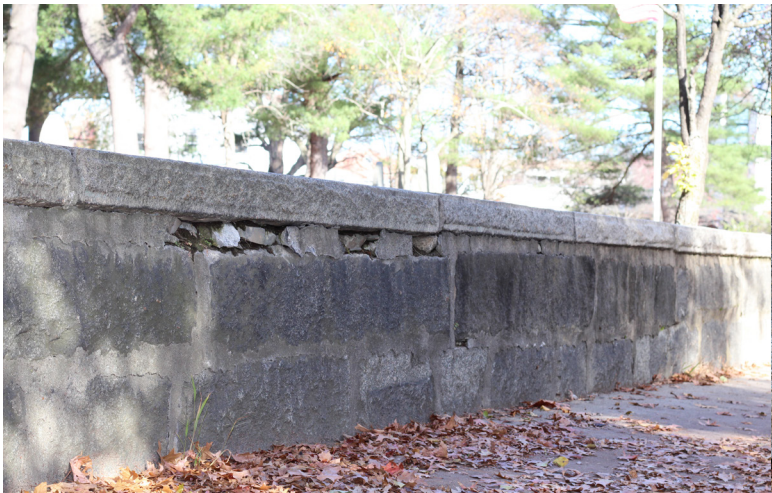
4. Pleasant Street wall - mortar missing from joints

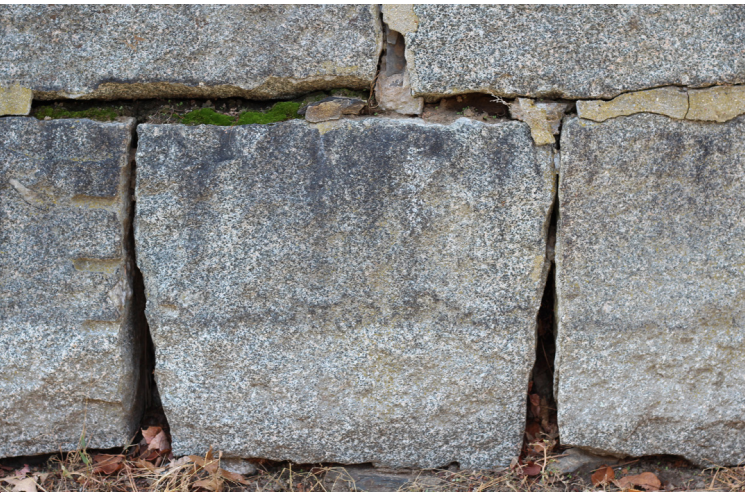
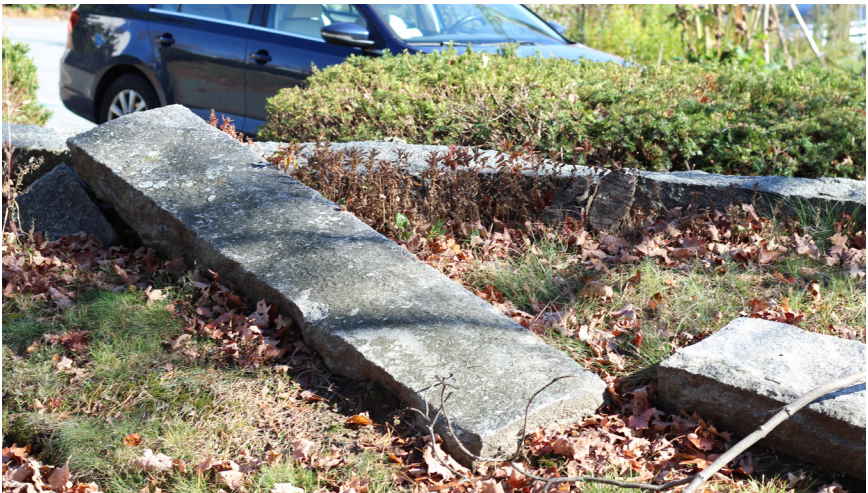
5. Coping stones lying next to wall

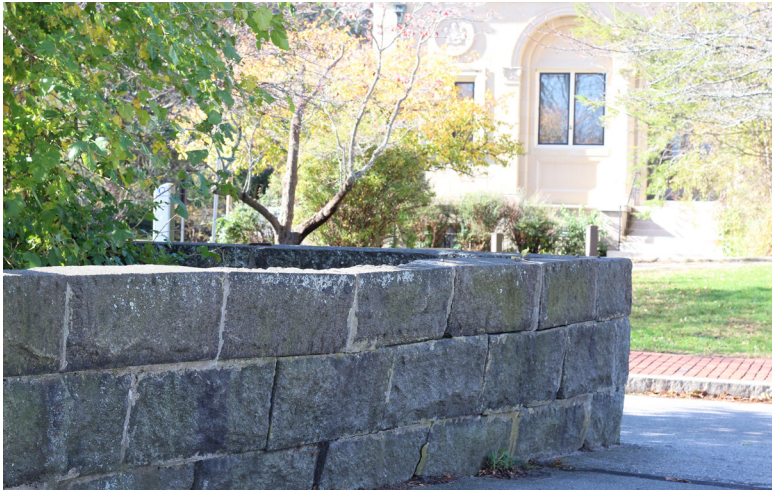
6. Northeast wall - stone, area of bulging

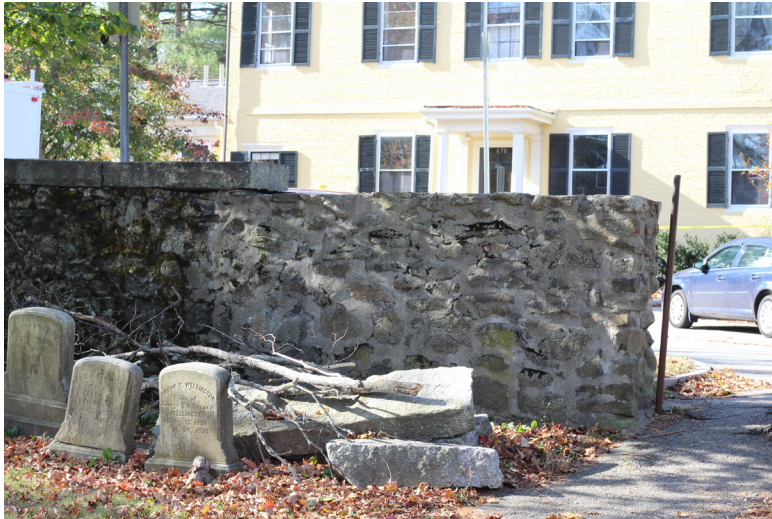
9. Peg Spengler Way wall - stone, moss growth

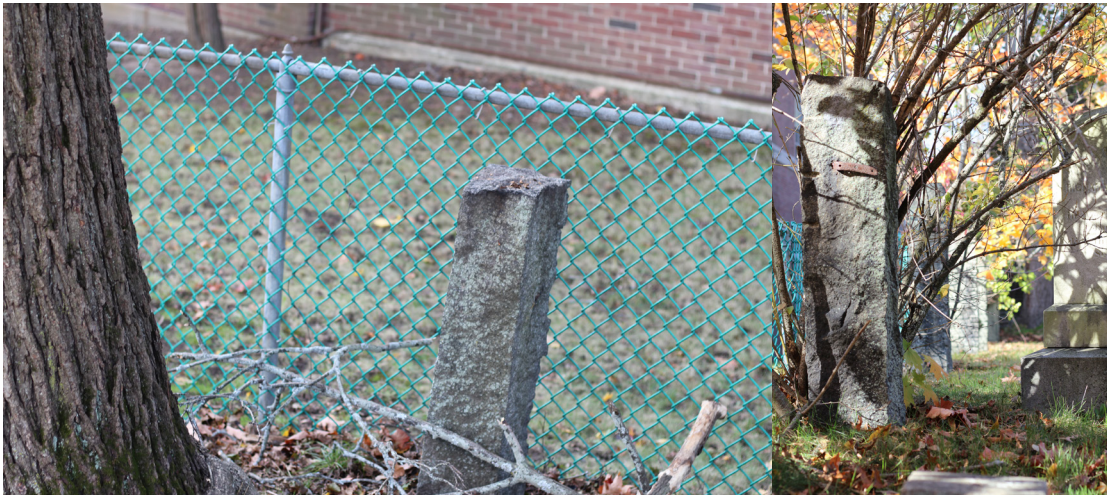
12. Granite posts, missing iron rail

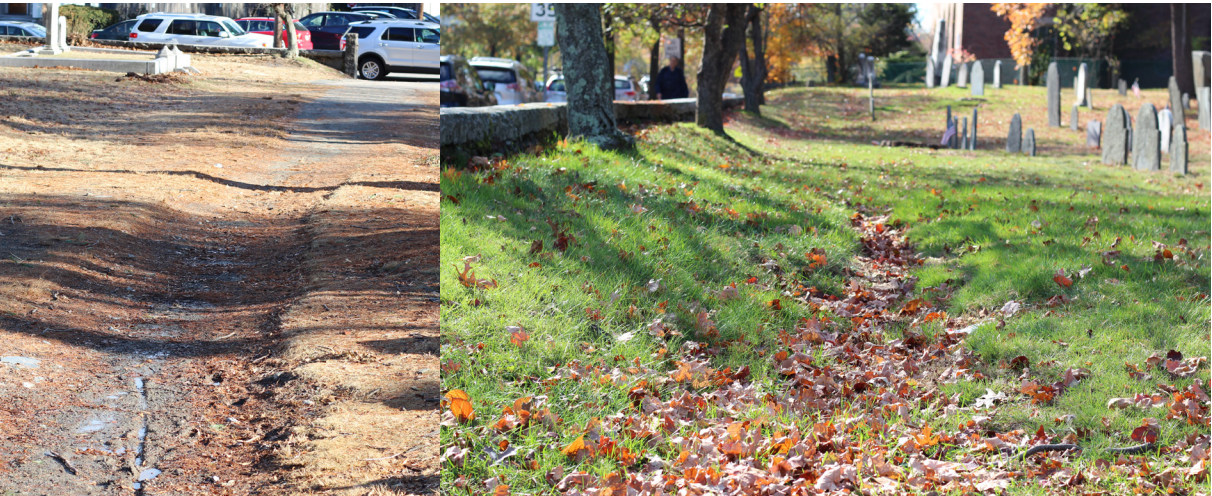
15. Low area

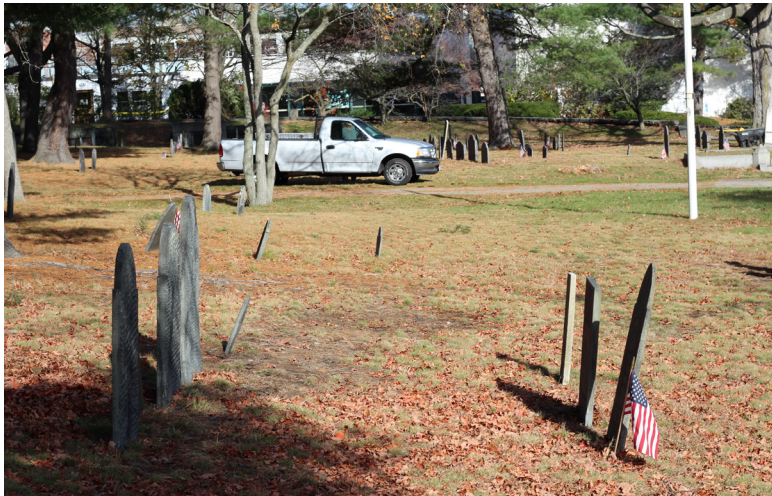
16. Bare lawn

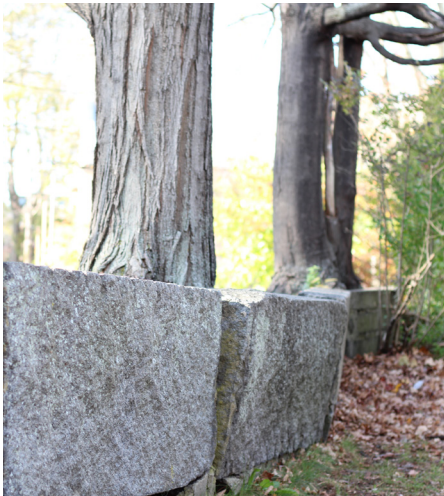
17. Trees growing into wall

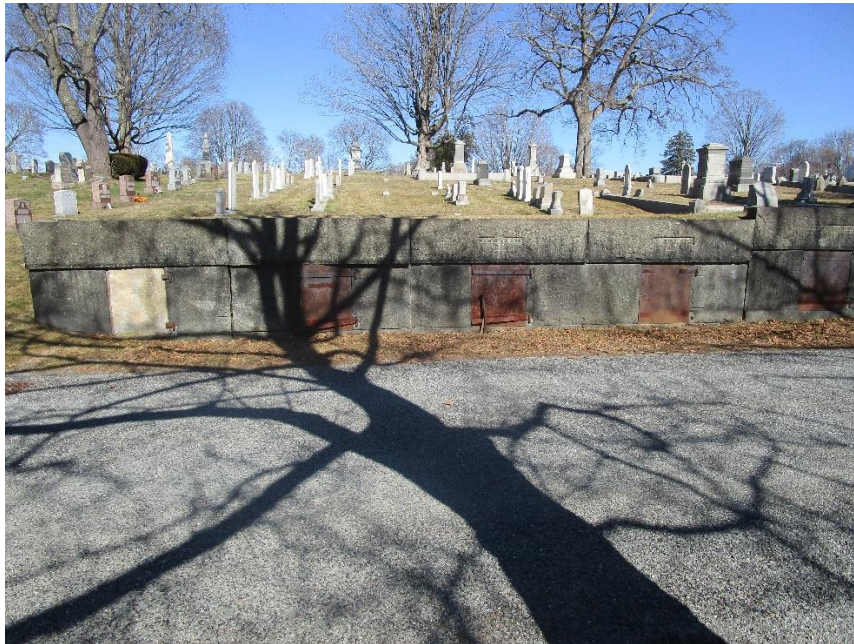
The five tombs are structurally interdependent, sharing common walls and a continuous front wall. The iron door at Tomb 1 is missing but the pintels remain in the granite.

stainless steel anchors. Replace the missing iron door from Tomb 1. Inspect the interior of the tombs when the doors are being replaced.

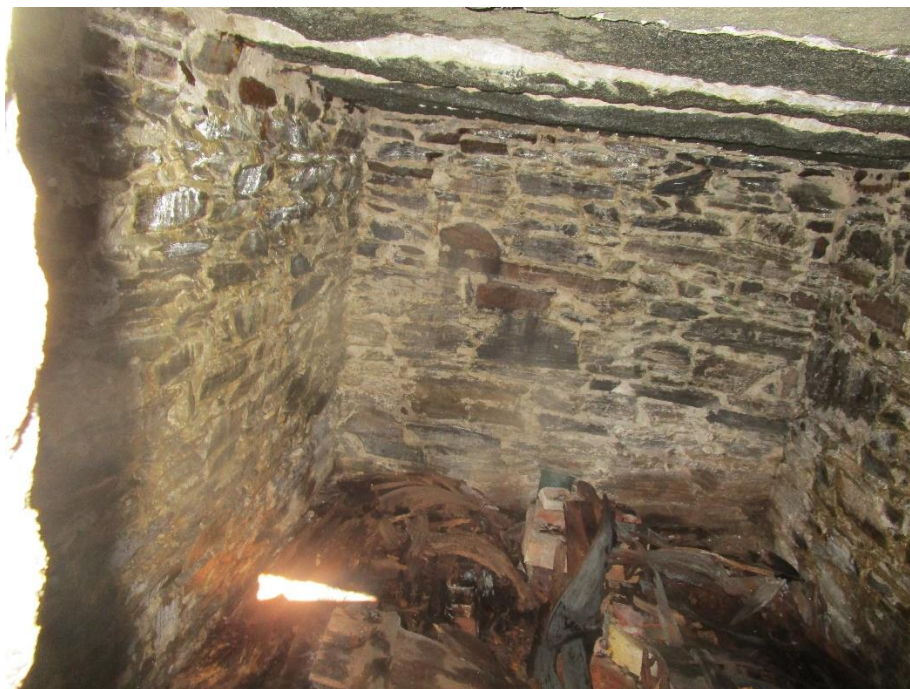
Tomb 2 interior. The random laid walls as well as the granite slab ceiling are in view. The floor is covered with the remnants of wooden caskets.

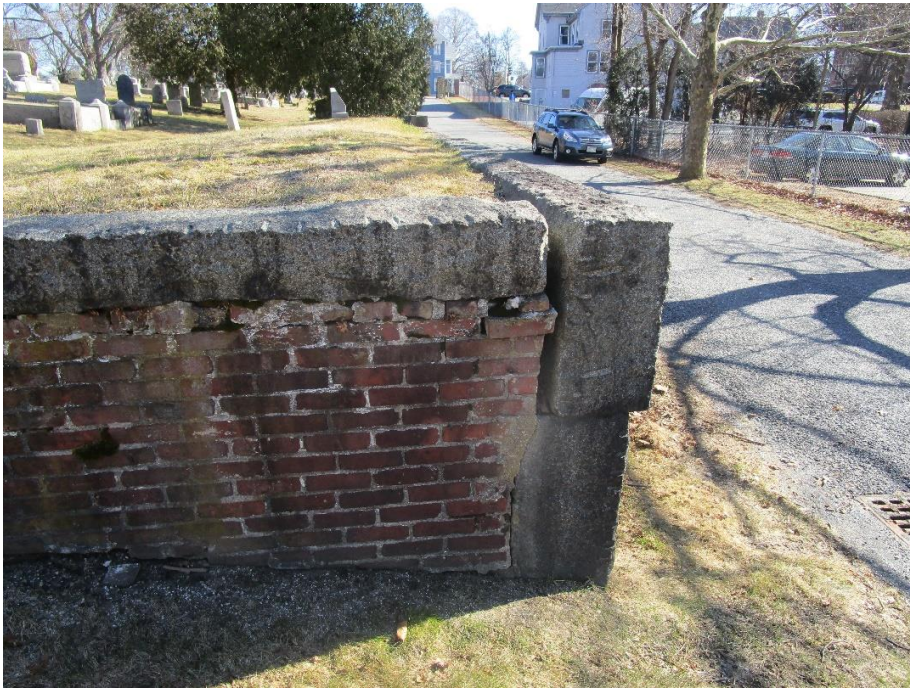
The brick retaining wall is leaning outward and the upper courses are debonded.

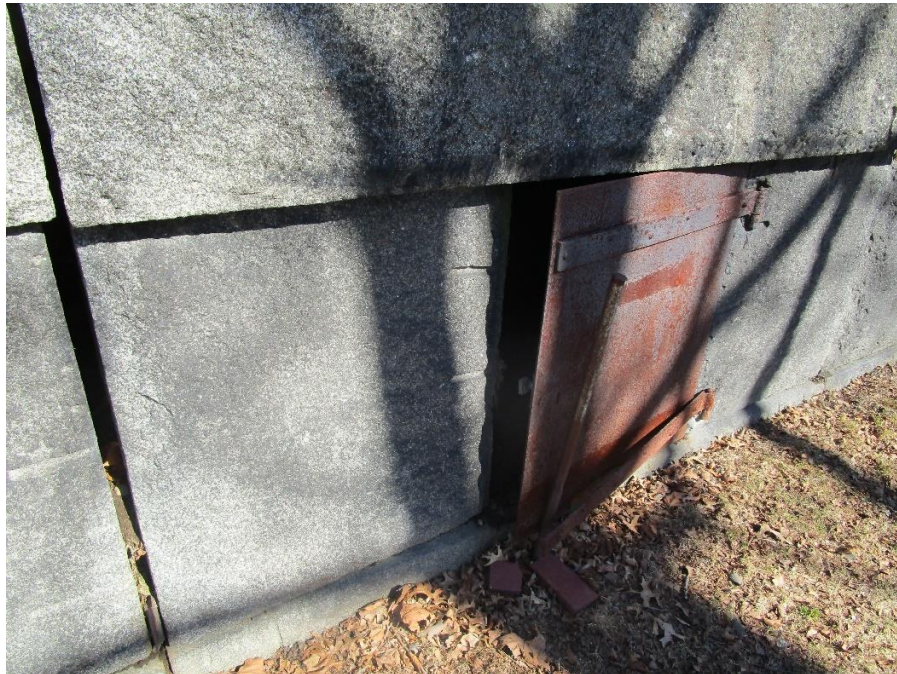
The metal doors are badly corroded and the straps securing them to the hinges are either missing or detaching from the sheet metal. The door closure system – a bar hammered into the ground is not very secure.

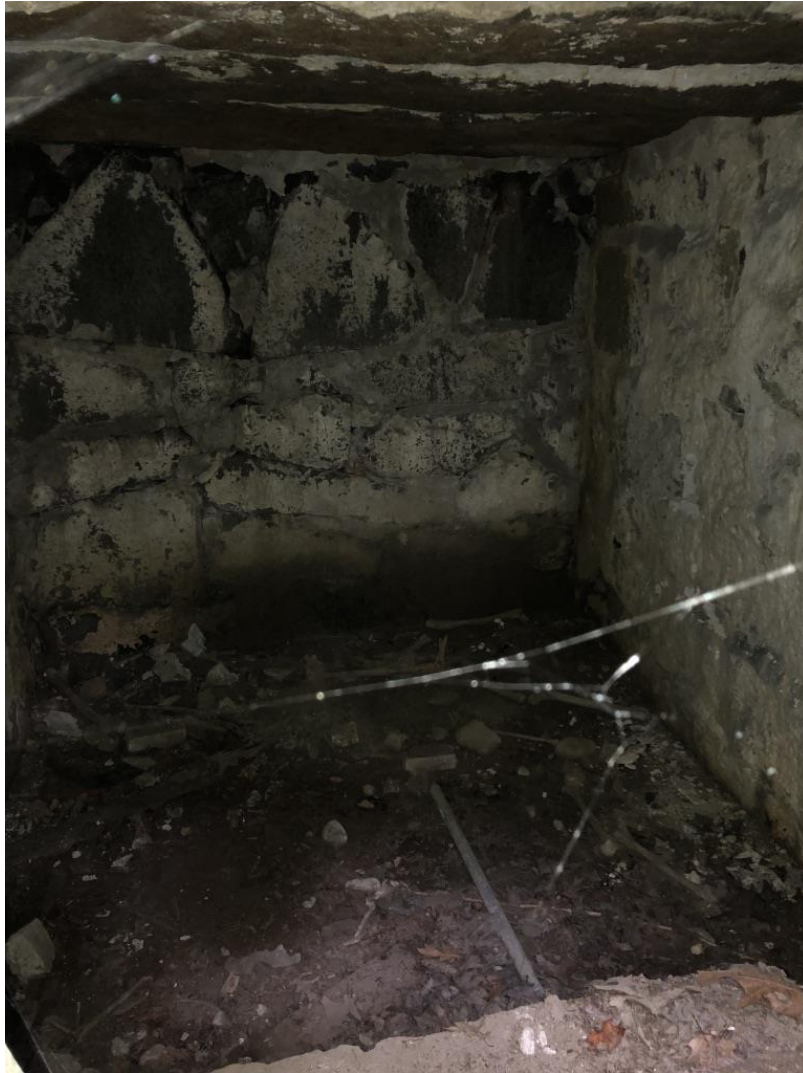
**Interior view of Seth Frost Tomb with well-constructed rear wall that is in good condition. Note that granite roof slabs are supported by the side wall which is also in good condition. The last slab at the rear is wider and is supported by both the sidewalls and the rear wall. This detail is the same for all of the flat slab tombs. Ref SKA 2 below for dimensions and location of grade on the front and back of the tombs.**

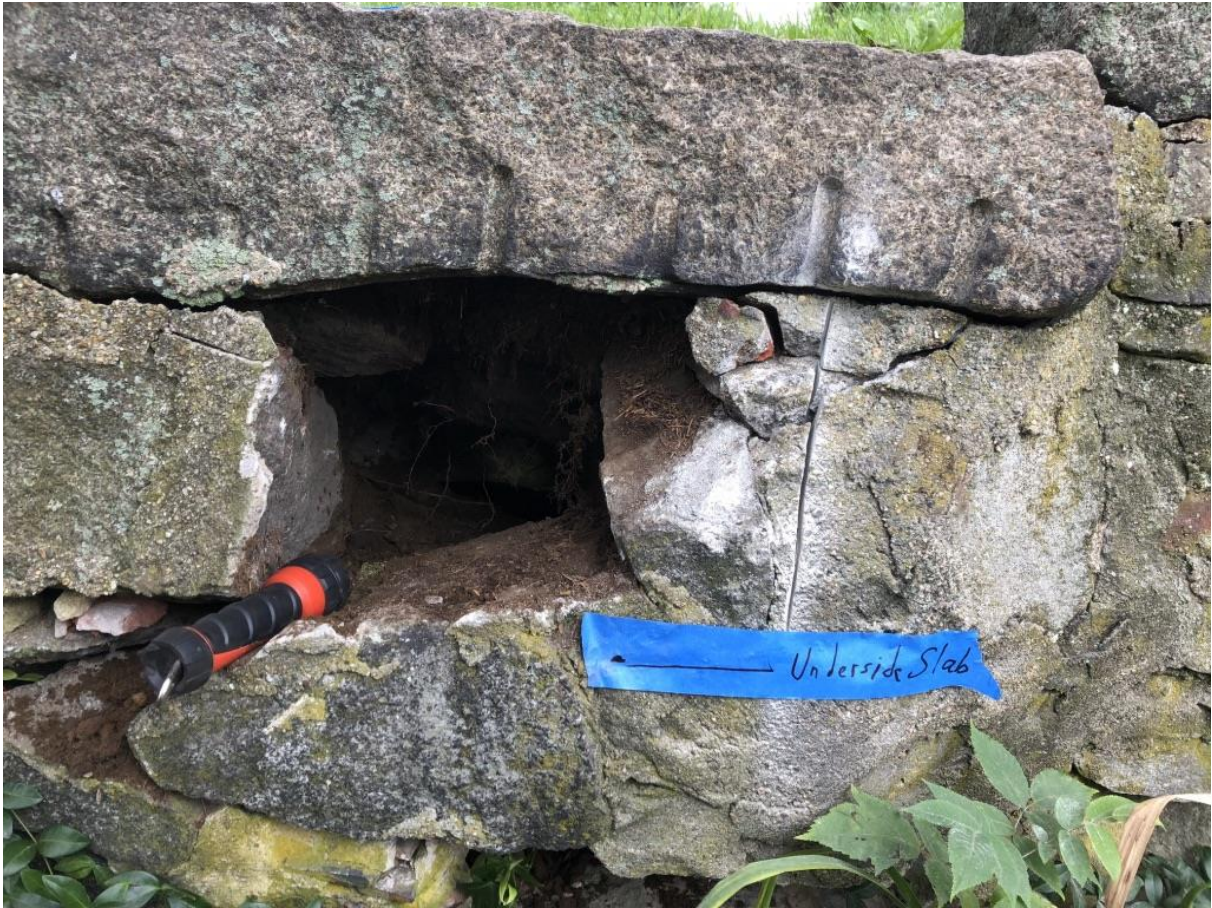
**Exterior probe at the rear of the James Hill Tomb to verify the location of the underside of the slab. The underside of the granite slab closest to the perimeter wall is located about 15 inches above grade. Ref SKA 2 below. The location of the underside of the roof marks the top of the structural walls of the tomb. Ref first photograph of interior. As the perimeter wall is dissembled, the maximum portion of the structural wall that can be exposed is about 15 inches.**

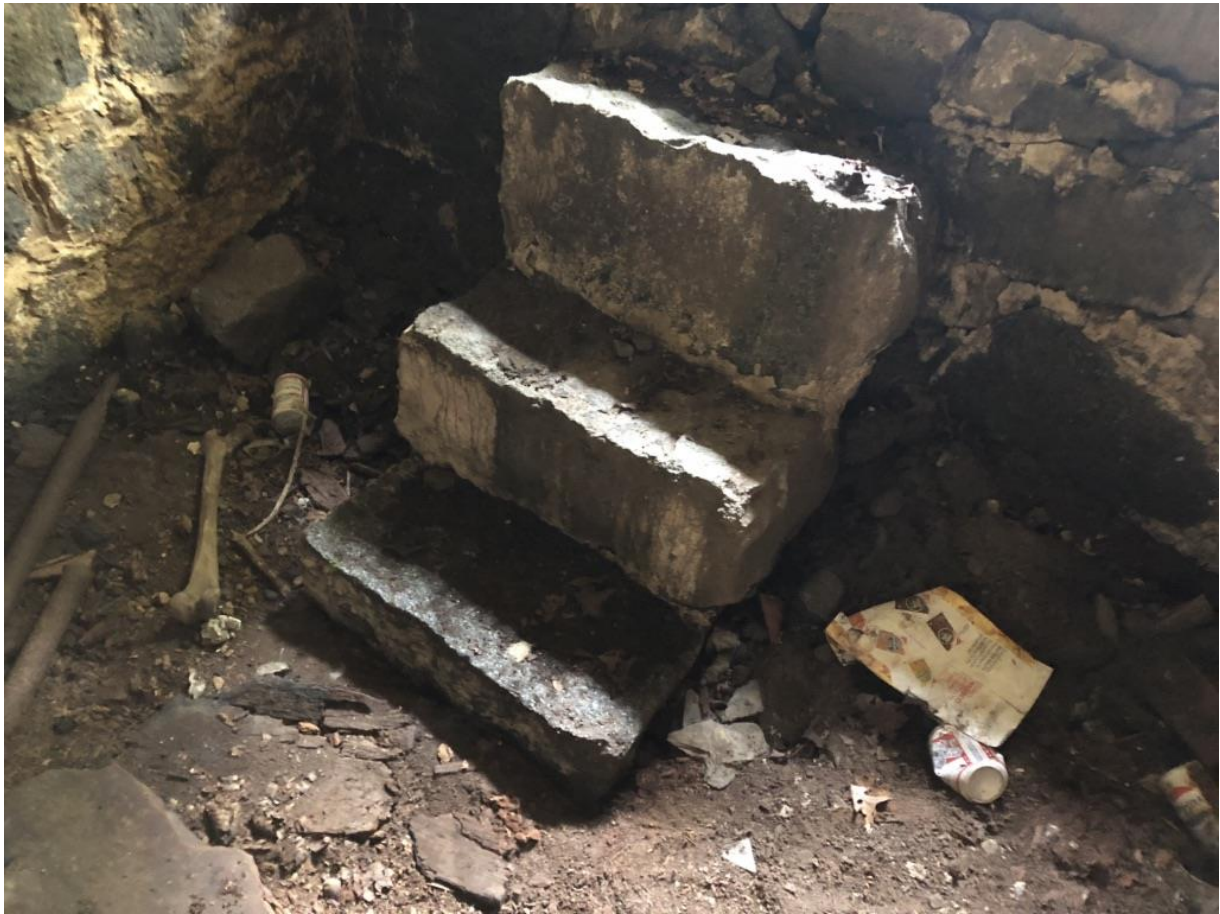
**Interior of the James Hill tomb at the steps. Note the human remains and trash on the floor. The floor of the tomb is unfinished and all of the caskets have rotted away. The remains are scattered around the floor. Ref Ska 1 below for dimensions of the interior.**

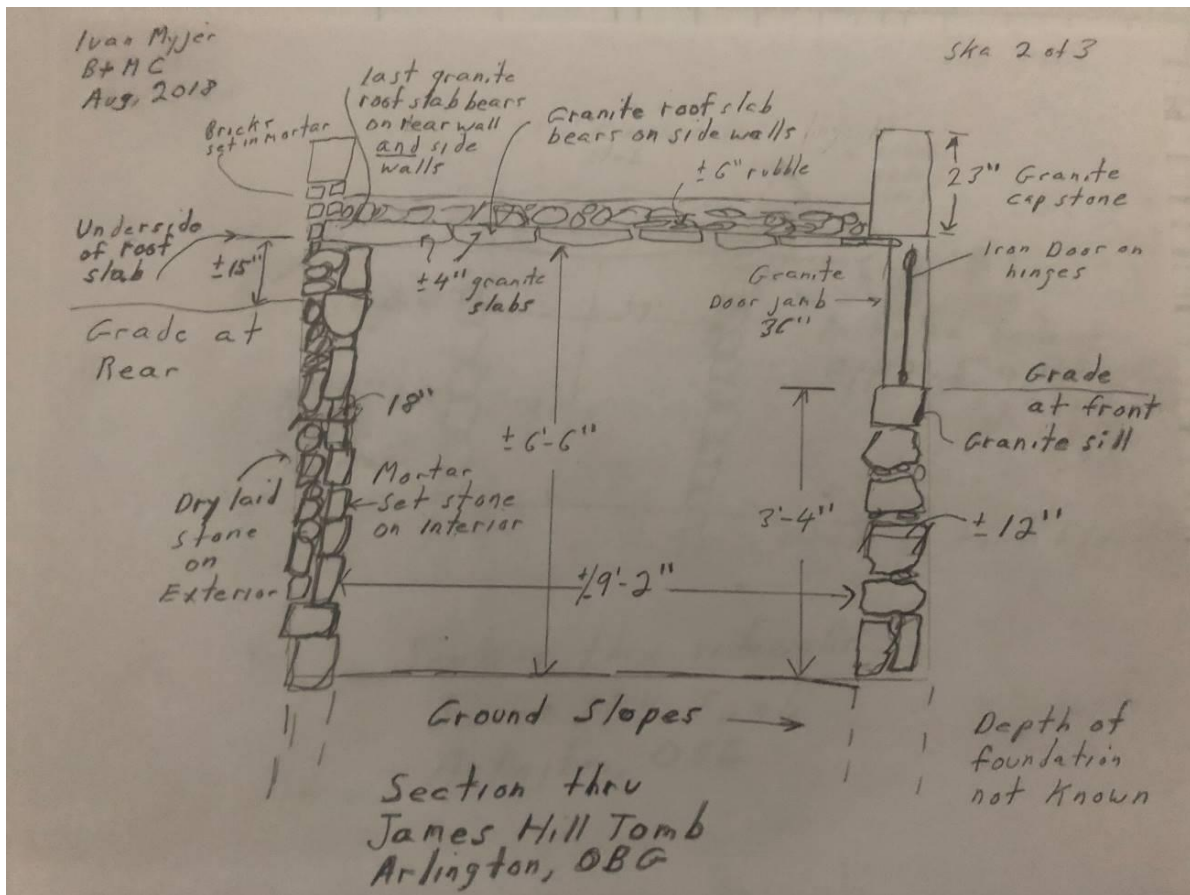
Ska 2 above shows that the perimeter wall and the structural walls of the tomb are joined. The structural walls of the tomb however were laid in mortar while the perimeter walls of the OBG were not. This distinction should make it very easy to determine where the perimeter wall ends and the structural walls begin during the disassembly of the perimeter walls. The 15-inch measurement shown above from the underside of the roof slab to the height of the soil on the rear wall defines the zone of the rear of the tombs that might be impacted by the disassembly and rebuilding of the west perimeter walls.

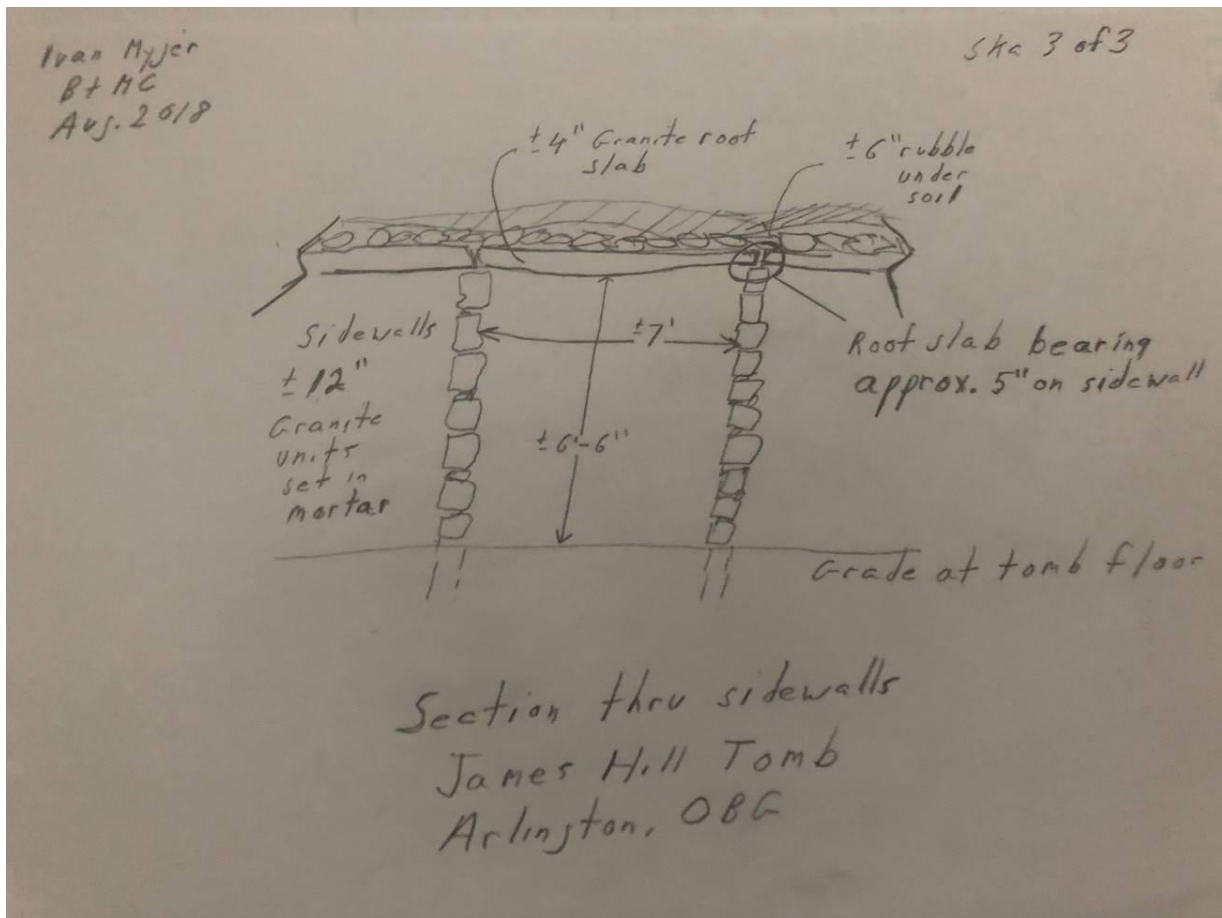
Ska 3 above shows that the sidewalls of the tombs are constructed from coursed granite set in mortar. The granite roof slabs bear on roughly half of the thickness of the sidewalls

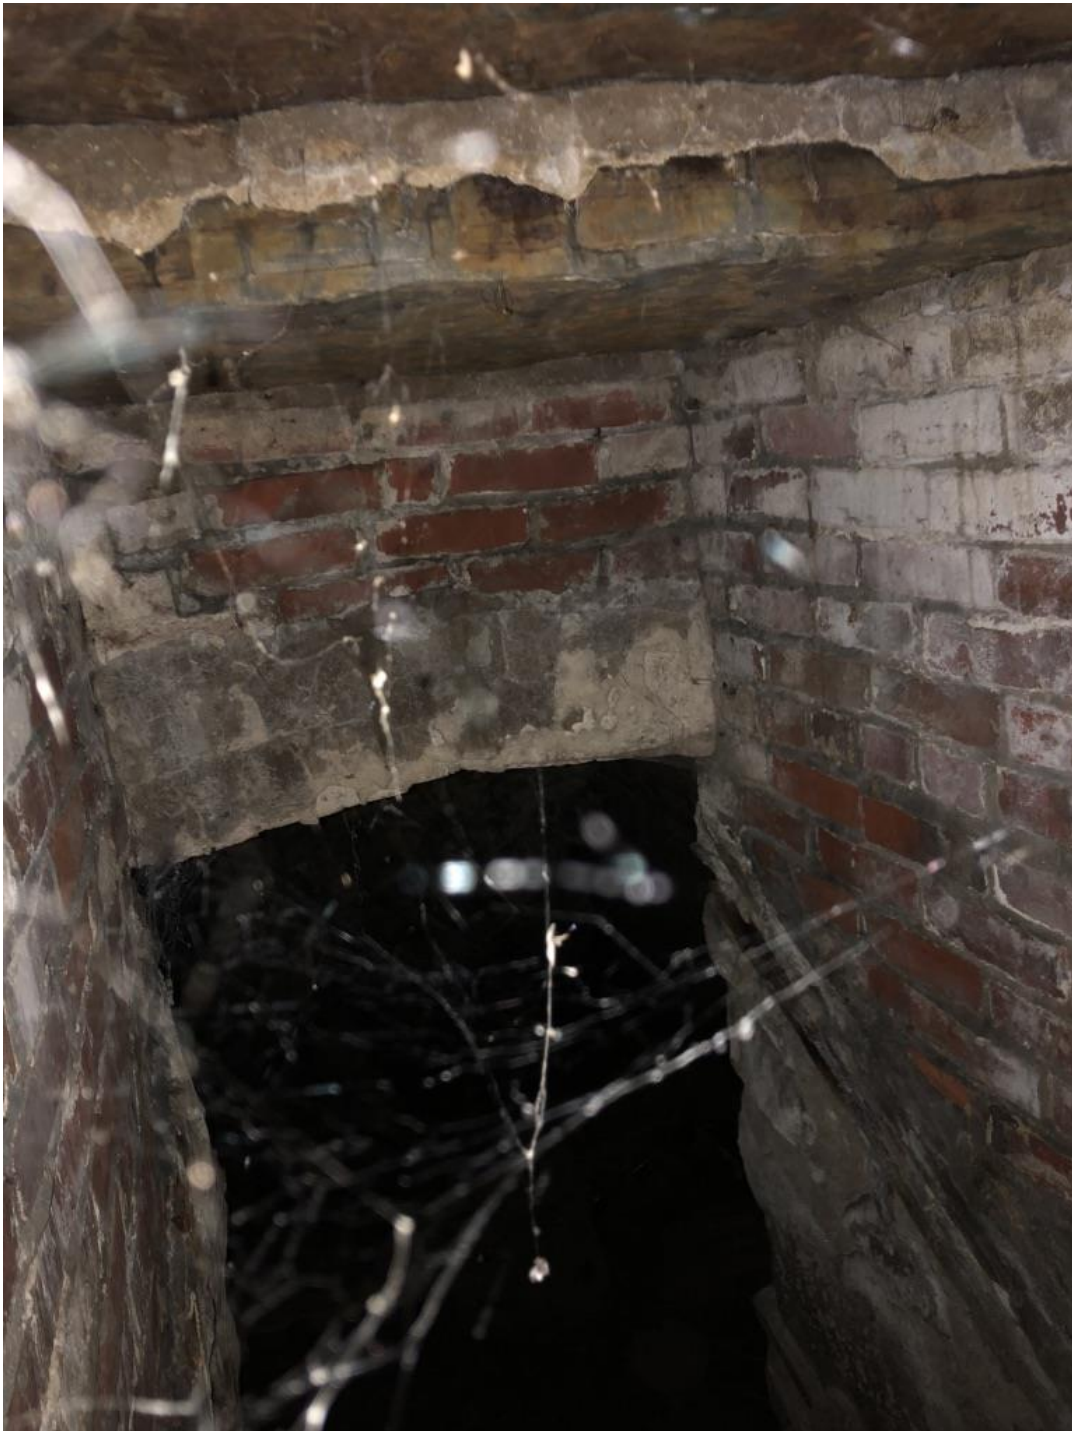
Photograph of interior of brick vaulted tomb on the norther edge of the burying ground. The photograph shows the small granite roofed entry chamber in the foreground and the brick vaulted burial chamber in the background. The burial chambers of the four tombs at the northern edge of the burying ground are deeper than the single chamber on the western edge.
